THE CHALLENGE:

THE SOLUTION:

Equipment: Lean Jet RB-1

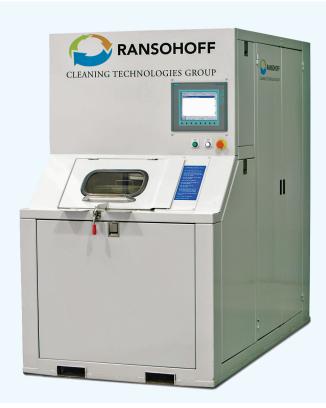
Sequence: Wash, Rinse, Blow-Off

Cleaning Mechansims: Spray, immersion, rotation & Ultrasonics

Drying Mechansim: Heated Blow-Off

Features: Parts with internal bores and passages are thoroughly cleaned and efficiently dried

with the basket rotation feature.
